**REPORT ON THE TYPE THREE DESTRUCTIVE
SURVEY TO LOCATE AND ASCERTAIN THE NATURE
OF SUSPECTED ASBESTOS BASED MATERIALS**

**CLARKSON OSBORN
100 Penistone Road
Sheffield
S6 3AE**

**Dated: 29th October 2009
REPORT No: ASC/SUR/CS/0096**

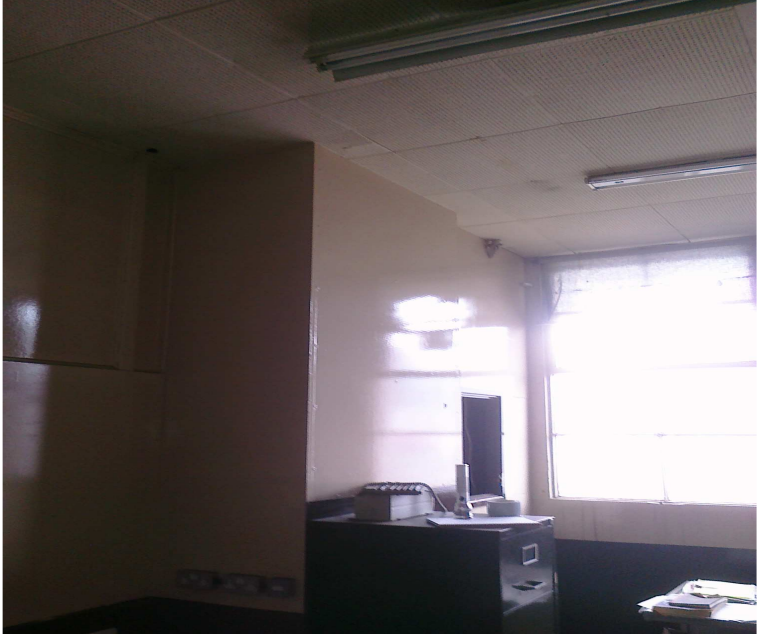
Component:	Cement Boarding	Sample No:	MB/01/01
Sampled By:	C Stephenson	Asbestos:	CHRYBOTILE

Condition:	Fair

Friability:	Low		
Surface Treatment:	None		
Position:	Internal		
Accessibility:	Low		
Exposure:	Maintenance		
Room/Area Size:	N/A		
Approx. Amount of Material at Location:	3 sq.m		
Photo Number:	001	Action Priority:	N/A

Comments:	Asbestos Cement Panels to the Electrical Riser within the Office Area 01. NB This extend to the first floor level with lining panels present to the full height of the riser shaft ~ 4 metres
Recommendation:	Remove prior to demolition / refurbishment

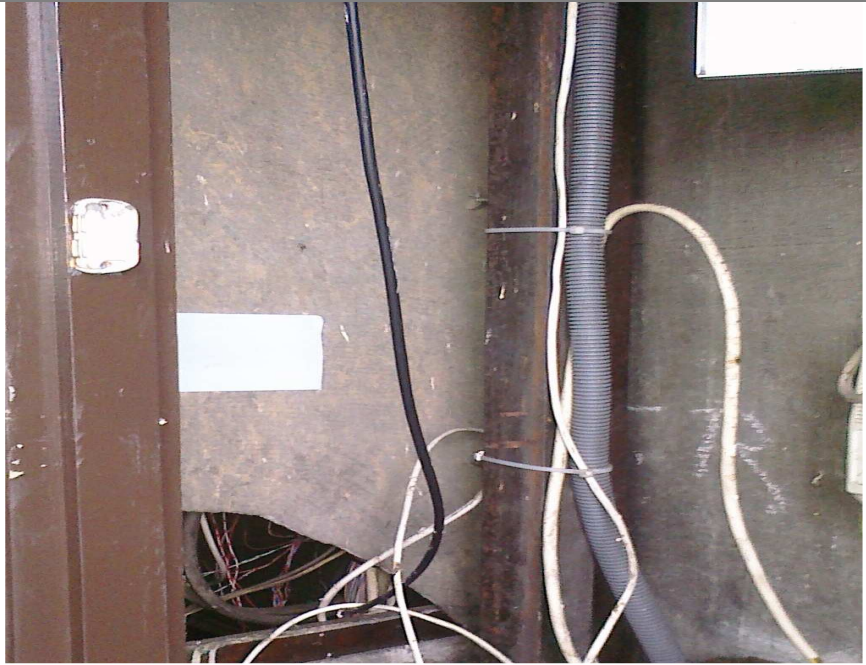
Component:	Cement Boarding	Sample No:	MB/01/01
Sampled By:	C Stephenson	Asbestos:	CHRYSTILE

Condition:	Fair

Friability:	Low		
Surface Treatment:	None		
Position:	Internal		
Accessibility:	Low		
Exposure:	Maintenance		
Room/Area Size:	N/A		
Approx. Amount of Material at Location:	3 sq.m		
Photo Number:	003	Action Priority:	N/A

Comments:	Asbestos Cement Panels to the Electrical Riser within the Office Area 01. NB This extend to the first floor level with lining panels present to the full height of the riser shaft ~ 4 metres
Recommendation:	Remove prior to demolition / refurbishment

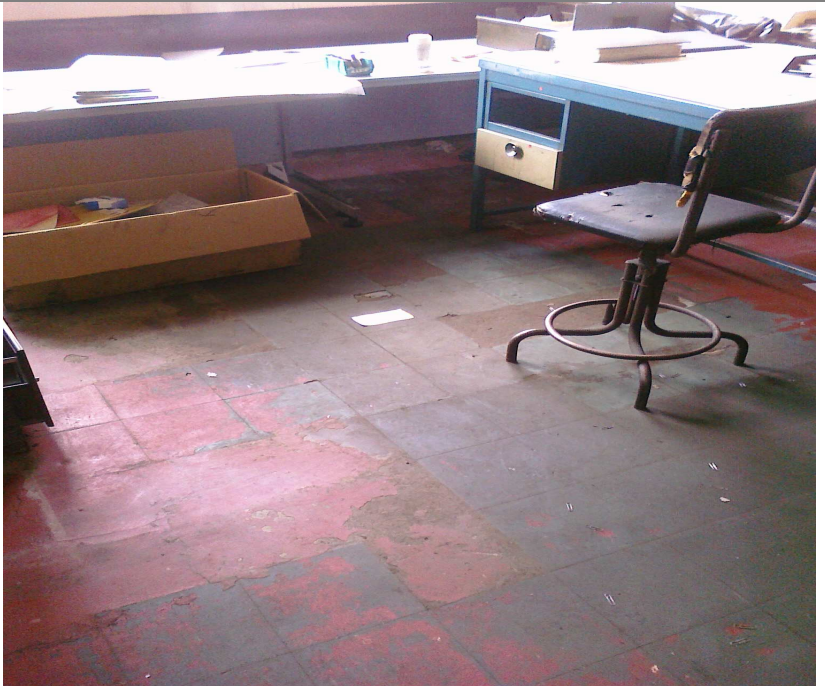
Component:	Thermoplastic	Sample No:	MB/01/02
Sampled By:	C Stephenson	Asbestos:	CHRYBOTILE

Condition:	Fair

Friability:	Low		
Surface Treatment:	None		
Position:	Internal		
Accessibility:	Low		
Exposure:	Maintenance		
Room/Area Size:	N/A		
Approx. Amount of Material at Location:	20 sq.m		
Photo Number:	003	Action Priority:	N/A

Comments:	Asbestos Containing Thermoplastic Floor Tiles within the Office Area 01.
Recommendation:	Remove prior to demolition / refurbishment

The sample of the bonded thermoplastic materials used as flooring (tiles and adhesive) within the above areas has been found to contain Chrysotile (white asbestos).

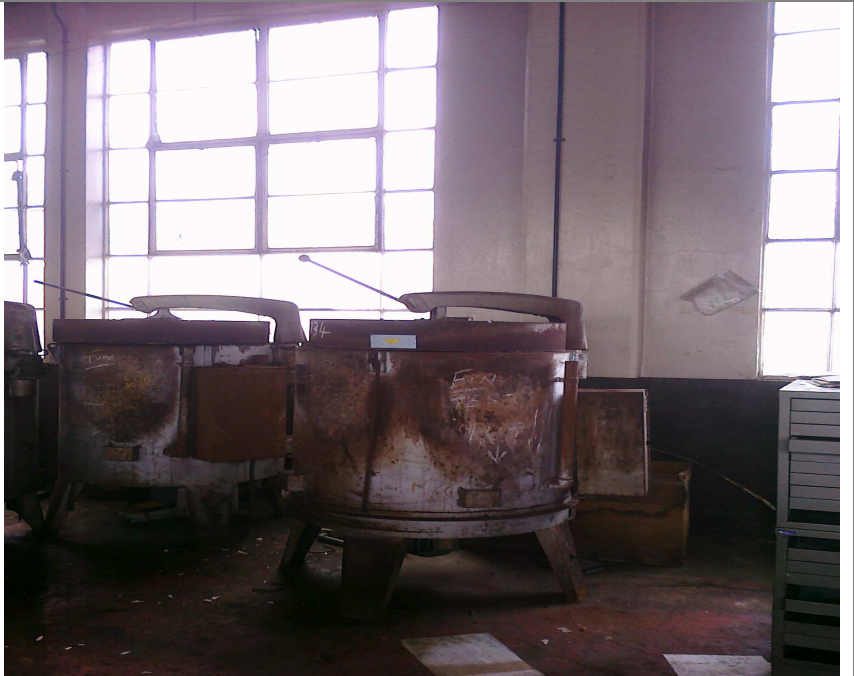
Component:	Woven Rope Seals	Sample No:	MB/01/03
Sampled By:	C Stephenson	Asbestos:	Chrysotile

Condition:	Fair

Friability:	High		
Surface Treatment:	None		
Position:	Internal		
Accessibility:	Low		
Exposure:	Maintenance		
Room/Area Size:	N/A		
Approx. Amount of Material at Location:	15 lin.m		
Photo Number:	004	Action Priority:	N/A

Comments:	Asbestos containing woven products to the edge of the redundant vessels stored at ground floor level
Recommendation:	Remove prior to demolition / refurbishment

The sample of the rope seals to the top of the redundant vessels within the ground floor area has been found to contain Chrysotile (white asbestos).

The *Control of Asbestos Regulations 2006* does not require the use of a licensed asbestos removal contractor for the removal of asbestos containing woven products. However they do require them to be disposed of as asbestos waste and for the removal to be carried out under controlled conditions, due to the possibility of airborne fibre release.

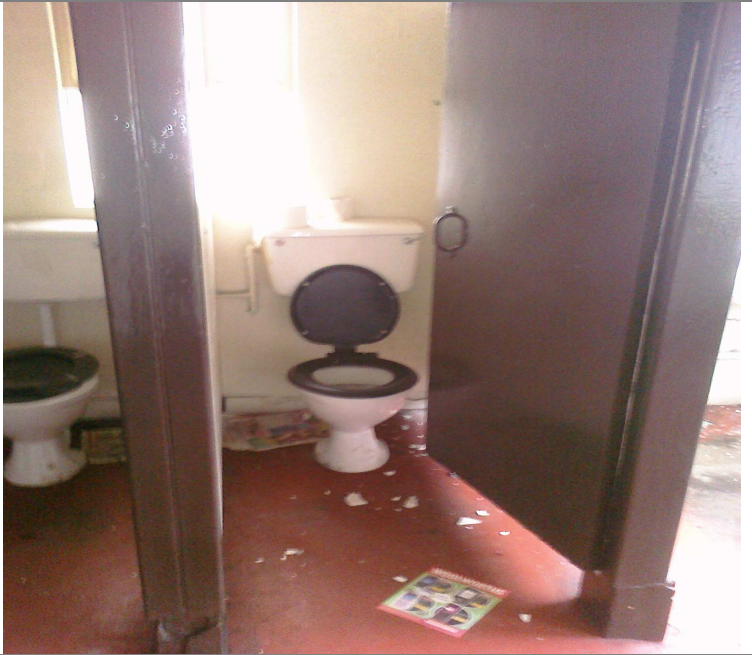
Component:	Thermoplastic	Sample No:	As MR/01/01
Sampled By:	C Stephenson	Asbestos:	AMOSITE

Condition:	Good

Friability:	Low		
Surface Treatment:	None		
Position:	Internal		
Accessibility:	Low		
Exposure:	Maintenance		
Room/Area Size:	N/A		
Approx. Amount of Material at Location:	4 no. Sets		
Photo Number:	005	Action Priority:	N/A

Comments:	Asbestos containing thermoplastic sanitary ware ~ 4 sets
Recommendation:	Remove prior to demolition / refurbishment

The sample of the bonded thermoplastic materials used as sanitary ware (cisterns and seats) within the ground floor and first floor toilet areas has been found to contain Amosite (brown asbestos).

The *Control of Asbestos Regulations 2006* does not require the use of a licensed asbestos removal contractor for the removal of asbestos containing thermoplastic products. However they do require them to be disposed of as asbestos waste and for the removal to be carried out under controlled conditions, due to the possibility of airborne fibre release.

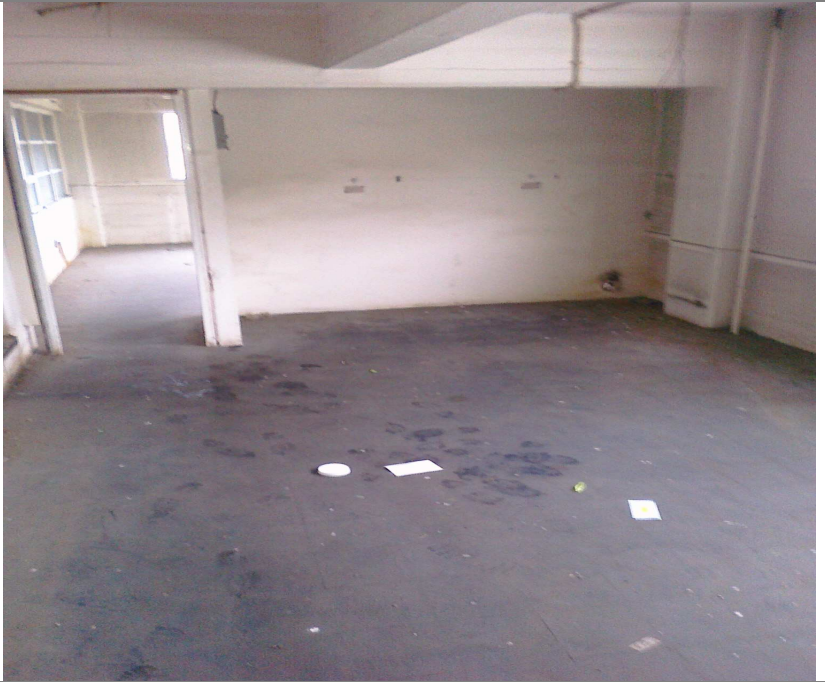
Component:	Thermoplastic	Sample No:	MB/06/01
Sampled By:	C Stephenson	Asbestos:	CHRYBOTILE

Condition:	Fair

Friability:	Low		
Surface Treatment:	None		
Position:	Internal		
Accessibility:	Low		
Exposure:	Maintenance		
Room/Area Size:	N/A		
Approx. Amount of Material at Location:	80 sq.m		
Photo Number:	006	Action Priority:	N/A

Comments:	Asbestos Containing Thermoplastic Floor Tiles within the Office Area 06.
Recommendation:	Remove prior to demolition / refurbishment

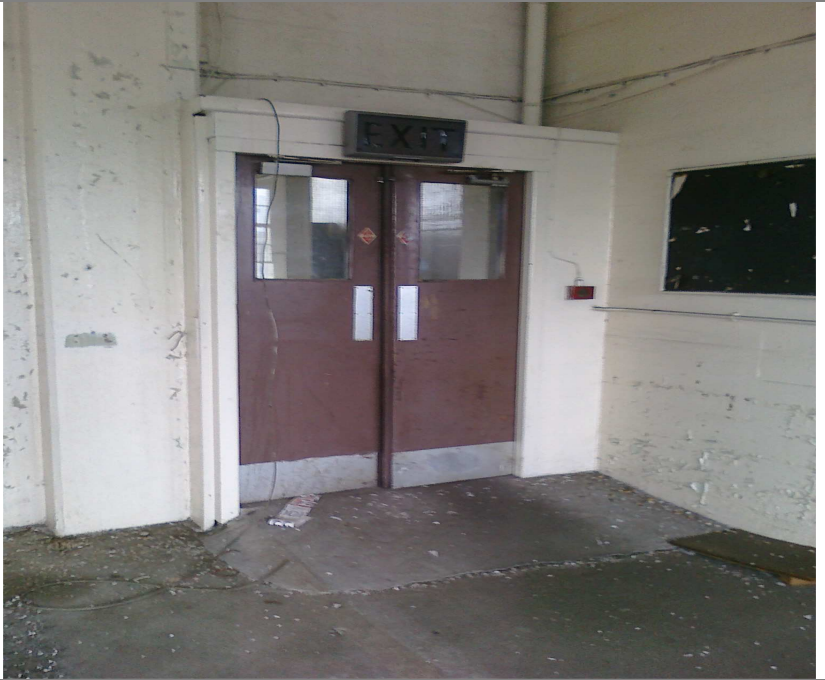
Component:	AIB Panels	Sample No:	MB/07/01
Sampled By:	C Stephenson	Asbestos:	AMOSITE & CHRYSOTILE

Condition:	Fair

Friability:	Low		
Surface Treatment:	None		
Position:	Internal		
Accessibility:	Low		
Exposure:	Maintenance		
Room/Area Size:	N/A		
Approx. Amount of Material at Location:	6 sq.m per area		
Photo Number:	007	Action Priority:	N/A

Comments:	Asbestos Insulation Boarding fire protection to doorway surrounds. 6 no. sets of doors over three floors.
Recommendation:	Remove prior to demolition / refurbishment

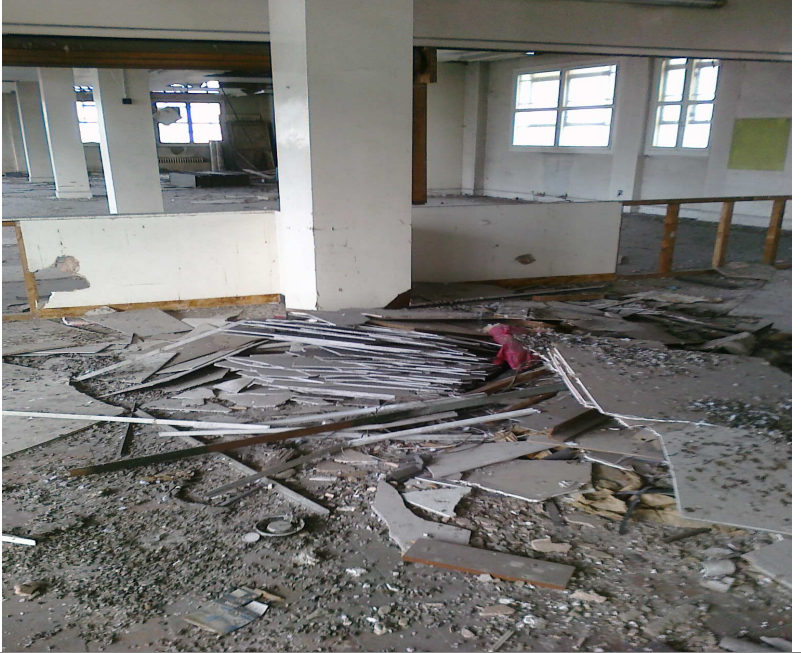
Samples taken from the above reference locations were found to contain Amosite / Chrysotile asbestos.

The materials are on the whole in very poor condition having been removed in an uncontrolled manner giving rise to extensive floor debris and contamination. Access to this floor should be restricted until such time as an asbestos abatement process is implemented.

Component:	AIB Panels & Debris	Sample No:	MB/09/01 & 02
Sampled By:	C Stephenson	Asbestos:	AMOSITE & CHRYSOTILE

Condition:	Very Poor

Friability:	High		
Surface Treatment:	None		
Position:	Internal		
Accessibility:	RESTRICT		
Exposure:	Maintenance		
Room/Area Size:	N/A		
Approx. Amount of Material at Location:	300 sq.m		
Photo Number:	008	Action Priority:	N/A

Comments:	AIB Ceilings badly damaged / destroyed. Debris across the main areas of the floor. Restrict access until abatement carried out.
Recommendation:	Remove immediately

Prior to any demolition works all Asbestos Insulation Boarding (AIB) should be removed by a licensed asbestos removal contractor under fully controlled conditions in accordance with the *Control of Asbestos Regulations 2006*.

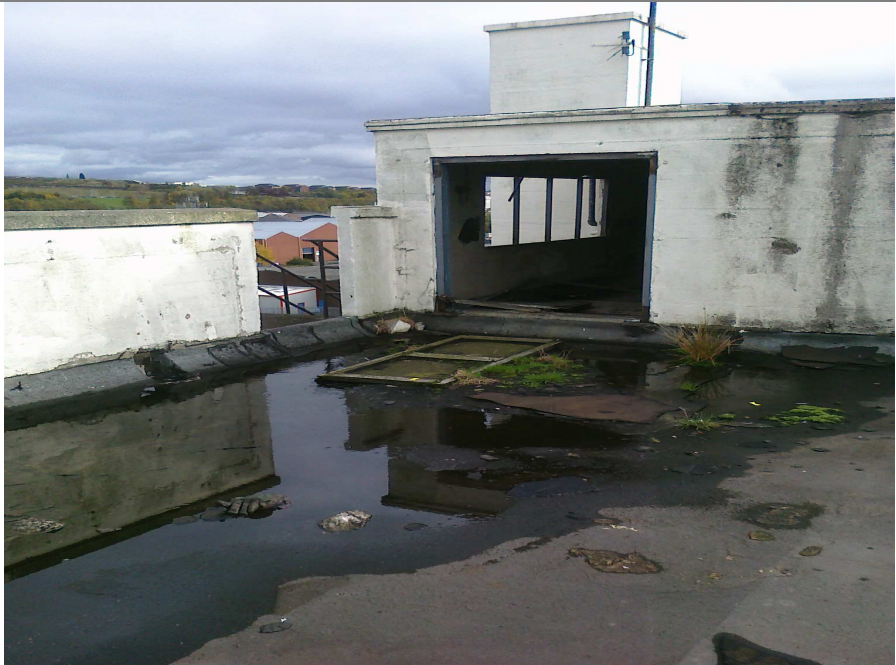
A sample taken from the above location was found to contain Chrysotile (white asbestos). The panels are damaged and asbestos containing floor debris is evident.

Component:	Asbestos Cement	Sample No:	MB/12/02
Sampled By:	C Stephenson	Asbestos:	CHRYBOTILE

Condition:	Poor

Friability:	Low		
Surface Treatment:	None		
Position:	External		
Accessibility:	Low		
Exposure:	Maintenance		
Room/Area Size:	N/A		
Approx. Amount of Material at Location:	3 sq.m		
Photo Number:	009	Action Priority:	N/A

Comments:	Asbestos Cement based panel to door set. Damaged with floor debris evident.
Recommendation:	Remove prior to demolition / refurbishment

The *Control of Asbestos Regulations 2006* does not require the use of a licensed asbestos removal contractor for the removal of asbestos cement products. However they do require asbestos cement to be disposed of as asbestos waste and for the removal to be carried out under controlled conditions, due to the possibility of airborne fibre release.

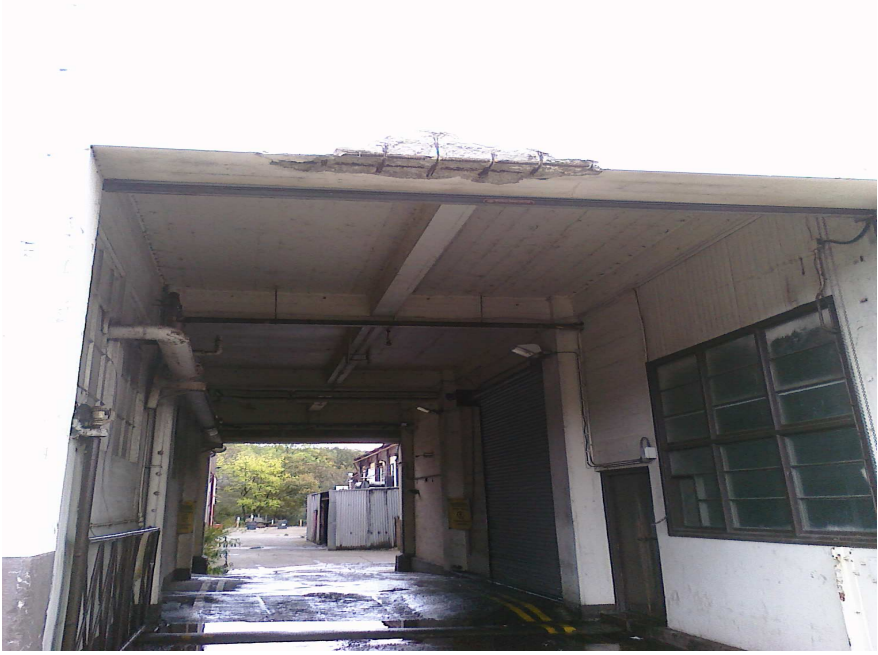
Samples taken from the above locations (two no.) have been found to contain Crocidolite/Amosite/Chrysotile.

The insulation to the pipework is in a poor condition in both areas with water ingress leading to damage and the possibility of floor debris arising.

Component:	Insulation	Sample No:	MB/13/01 & 02
Sampled By:	C Stephenson	Asbestos:	AMOSITE / CROCIDOLITE / CHRYBOTILE

Condition:	Fair

Friability:	Low		
Surface Treatment:	Canvas Wrap		
Position:	External		
Accessibility:	Low		
Exposure:	Maintenance		
Room/Area Size:	N/A		
Approx. Amount of Material at Location:	30 lin.m		
Photo Number:	010	Action Priority:	N/A

Comments:	Asbestos Insulation to small bore service pipework at high level. Damage in some localised areas due to water ingress.
Recommendation:	Remove prior to demolition / refurbishment

Prior to any demolition works all Asbestos Insulation (AI) should be removed by a licensed asbestos removal contractor under fully controlled conditions in accordance with the *Control of Asbestos Regulations 2006*.

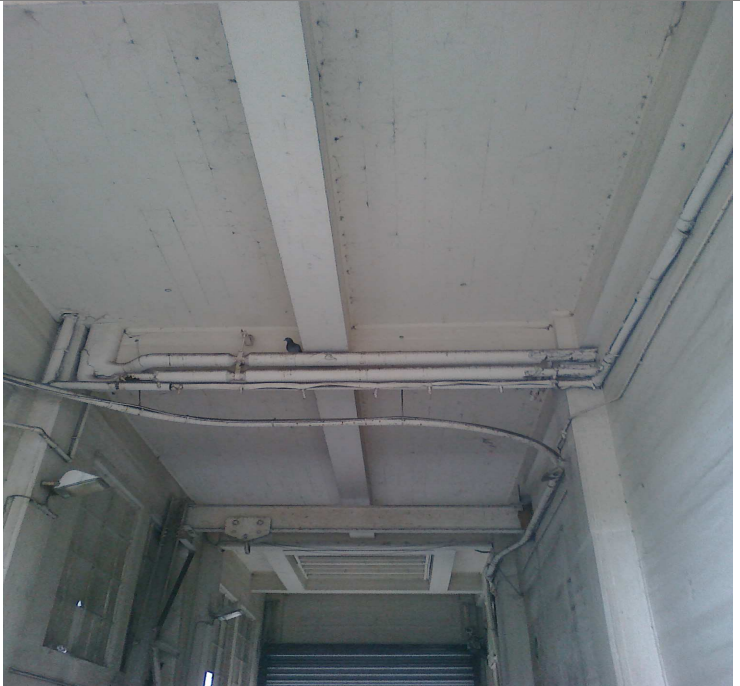
Component:	Insulation	Sample No:	MB/13/01 & 02
Sampled By:	C Stephenson	Asbestos:	AMOSITE / CROCIDOLITE / CHRYBOTILE

Condition:	Fair

Friability:	Low		
Surface Treatment:	Canvas Wrap		
Position:	External		
Accessibility:	Low		
Exposure:	Maintenance		
Room/Area Size:	N/A		
Approx. Amount of Material at Location:	30 lin.m		
Photo Number:	011	Action Priority:	N/A

Comments:	Asbestos Insulation to small bore service pipework at high level. Damage in some localised areas due to water ingress.
Recommendation:	Remove prior to demolition / refurbishment

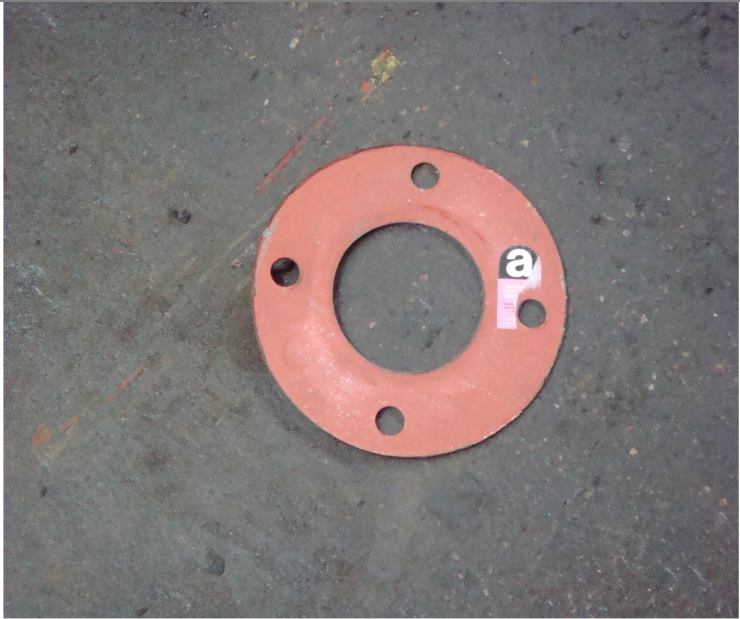
Component:	CAF Gasket	Sample No:	N/A
Sampled By:	C Stephenson	Asbestos:	CHRYBOTILE

Condition:	Fair

Friability:	Low		
Surface Treatment:	N/A		
Position:	Internal		
Accessibility:	High		
Exposure:	Maintenance		
Room/Area Size:	N/A		
Approx. Amount of Material at Location:	10 no.		
Photo Number:	012	Action Priority:	N/A

Comments:	CAF Gaskets found throughout the area. Discarded from other processes.
Recommendation:	Remove prior to demolition / refurbishment

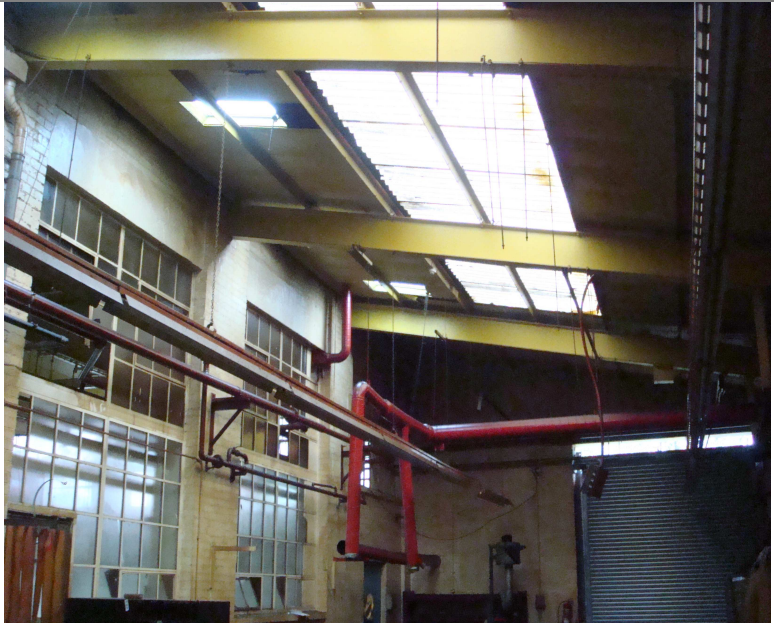
Samples taken from the above reference locations were found to contain Chrysotile asbestos.

The materials are on the whole in good condition having received only minor damage at time of survey. The coating is approximately 5mm in thickness and is unsealed. This is a factory applied coating and is in place as an insulant to protect against cold and subsequent condensation. In light of this the panels are classed in the surveyor's opinion as insulation boarding and hence their removal is a licensable activity,

Component:	Insulation Board	Sample No:	TD/11/01 & 02
Sampled By:	C Stephenson	Asbestos:	CHRYBOTILE

Condition:	Fair

Friability:	High		
Surface Treatment:	None		
Position:	Internal		
Accessibility:	Low		
Exposure:	Maintenance		
Room/Area Size:	N/A		
Approx. Amount of Material at Location:	400 sq.m		
Photo Number:	013	Action Priority:	N/A

Comments:	Asbestos coated insulation boarding to the roof and side walls of the machine shop structure. Coating is ~ 5mm in thickness and unsealed.
Recommendation:	Remove prior to demolition / refurbishment

Prior to any demolition works all Asbestos Insulation Boarding (AIB) should be removed by a licensed asbestos removal contractor under fully controlled conditions in accordance with the *Control of Asbestos Regulations 2006*.

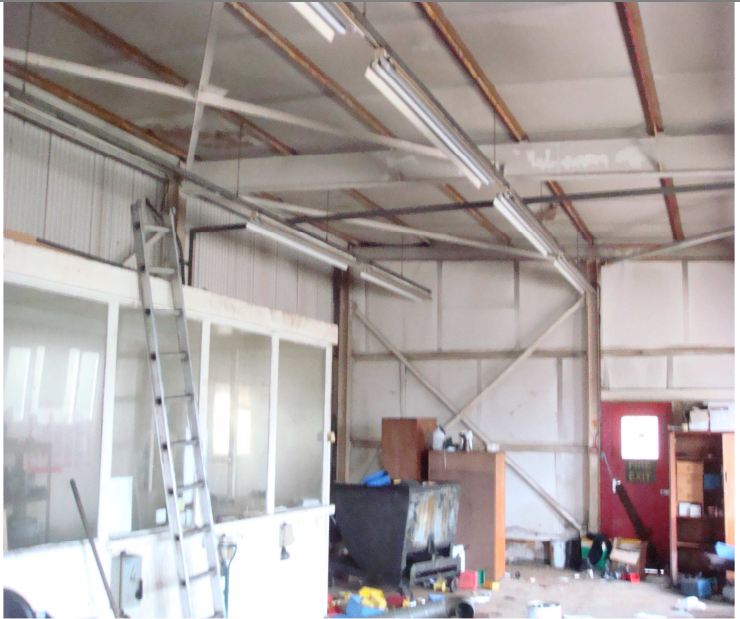
Component:	Asbestos Cement	Sample No:	MA/01/01
Sampled By:	C Stephenson	Asbestos:	CHRYBOTILE

Condition:	Fair

Friability:	Low	
Surface Treatment:	N/A	
Position:	Internal / External	
Accessibility:	High	
Exposure:	Maintenance	
Room/Area Size:	N/A	
Approx. Amount of Material at Location:	400 sq.m.	
Photo Number:	014

Comments:	Asbestos Cement panels forming internal partition walls and external wall cladding
Recommendation:	Remove prior to demolition / refurbishment

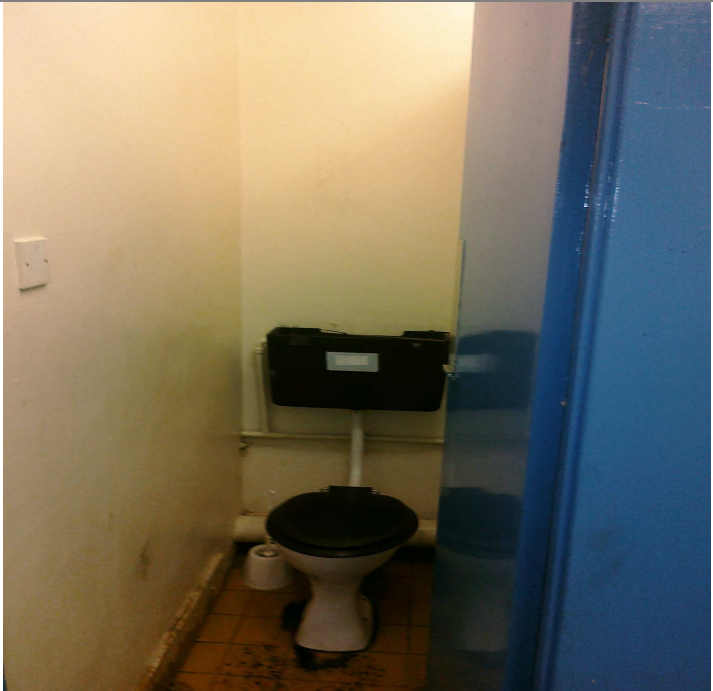
Component:	Thermoplastic	Sample No:	MR/01/01
Sampled By:	C Stephenson	Asbestos:	AMOSITE

Condition:	Fair

Friability:	Low		
Surface Treatment:	N/A		
Position:	Internal		
Accessibility:	High		
Exposure:	Maintenance		
Room/Area Size:	N/A		
Approx. Amount of Material at Location:	7 no. sets		
Photo Number:	015	Action Priority:	N/A

Comments:	Asbestos containing thermoplastic sanitary ware – 7 no. sets.
Recommendation:	Remove prior to demolition / refurbishment

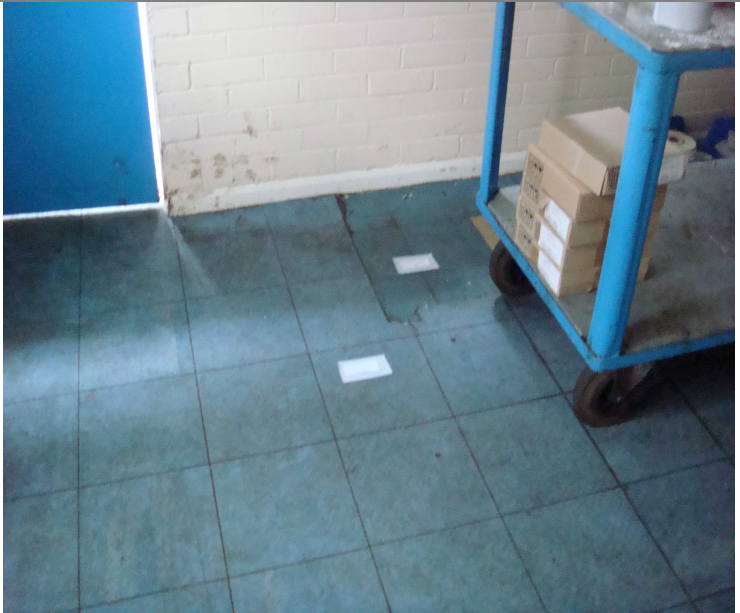
Component:	Thermoplastic Flooring	Sample No:	OFG/05/02
Sampled By:	C Stephenson	Asbestos:	CHRYBOTILE

Condition:	Fair

Friability:	Low		
Surface Treatment:	N/A		
Position:	Internal		
Accessibility:	High		
Exposure:	Maintenance		
Room/Area Size:	N/A		
Approx. Amount of Material at Location:	30 sq.m		
Photo Number:	016	Action Priority:	N/A

Comments:	Thermoplastic floor tile to the office area. Small sized tiles (blue).
Recommendation:	Remove prior to demolition / refurbishment

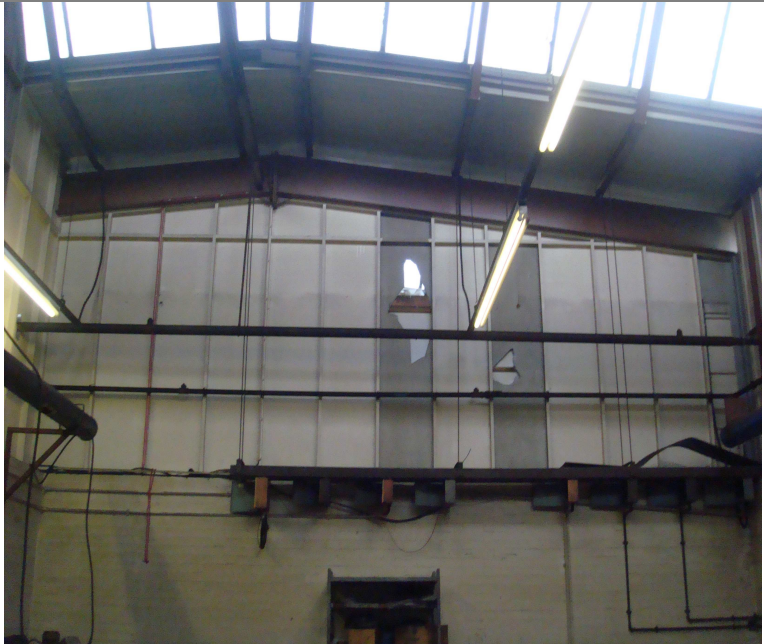
Component:	Insulation Boarding	Sample No:	OFG/07/01
Sampled By:	C Stephenson	Asbestos:	AMOSITE & CHRYSOTILE

Condition:	Fair (minor damage)

Friability:	Low		
Surface Treatment:	N/A		
Position:	Internal		
Accessibility:	High		
Exposure:	Maintenance		
Room/Area Size:	N/A		
Approx. Amount of Material at Location:	100 sq.m		
Photo Number:	017	Action Priority:	N/A

Comments:	Insulation boarding at high level forming wall partitions. Some damage with floor debris and debris on adjacent wall ledges evident.
Recommendation:	Remove prior to demolition / refurbishment

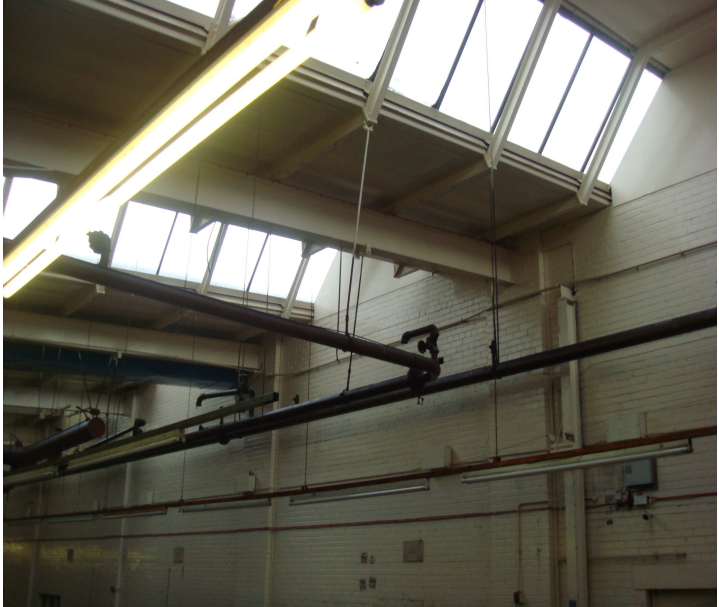
Component:	Insulation Boarding	Sample No:	As OFG/07/01
Sampled By:	C Stephenson	Asbestos:	AMOSITE & CHRYSOTILE

Condition:	Fair (minor damage)

Friability:	Low		
Surface Treatment:	N/A		
Position:	Internal		
Accessibility:	High		
Exposure:	Maintenance		
Room/Area Size:	N/A		
Approx. Amount of Material at Location:	40 sq.m		
Photo Number:	018	Action Priority:	N/A

Comments:	Insulation boarding at high level forming wall partitions. Some damage with floor debris and debris on adjacent wall ledges evident.
Recommendation:	Remove prior to demolition / refurbishment

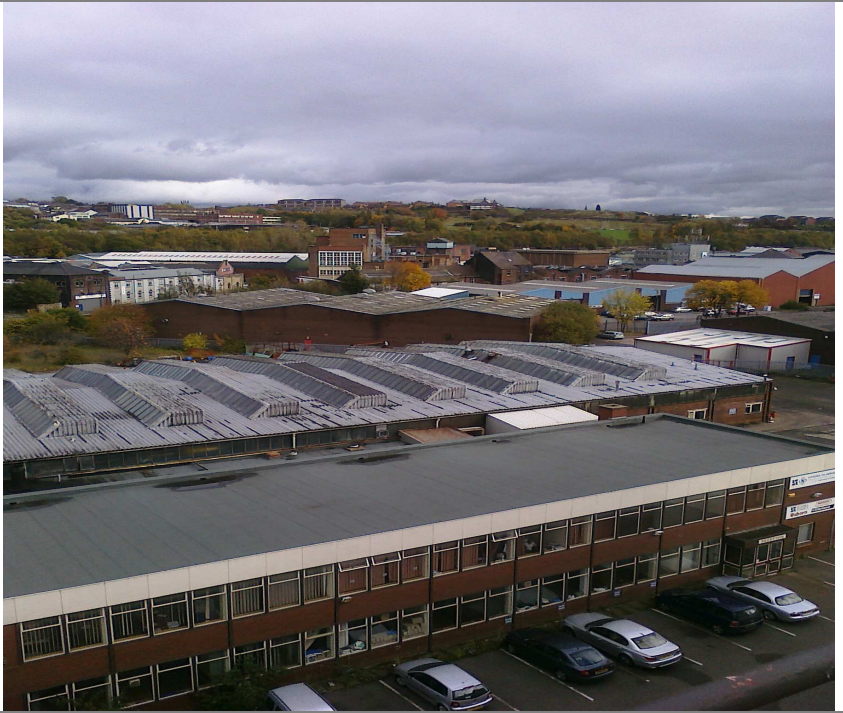
Component:	Insulation Boarding	Sample No:	As MA/01/01
Sampled By:	C Stephenson	Asbestos:	CHRYBOTILE

Condition:	Fair (minor damage)

Friability:	Low		
Surface Treatment:	N/A		
Position:	External		
Accessibility:	Low		
Exposure:	Maintenance		
Room/Area Size:	N/A		
Approx. Amount of Material at Location:	5000 sq.m		
Photo Number:	019	Action Priority:	N/A

Comments:	Asbestos cement materials forming roof / all panels and rain water goods throughout the site.
Recommendation:	Remove prior to demolition / refurbishment

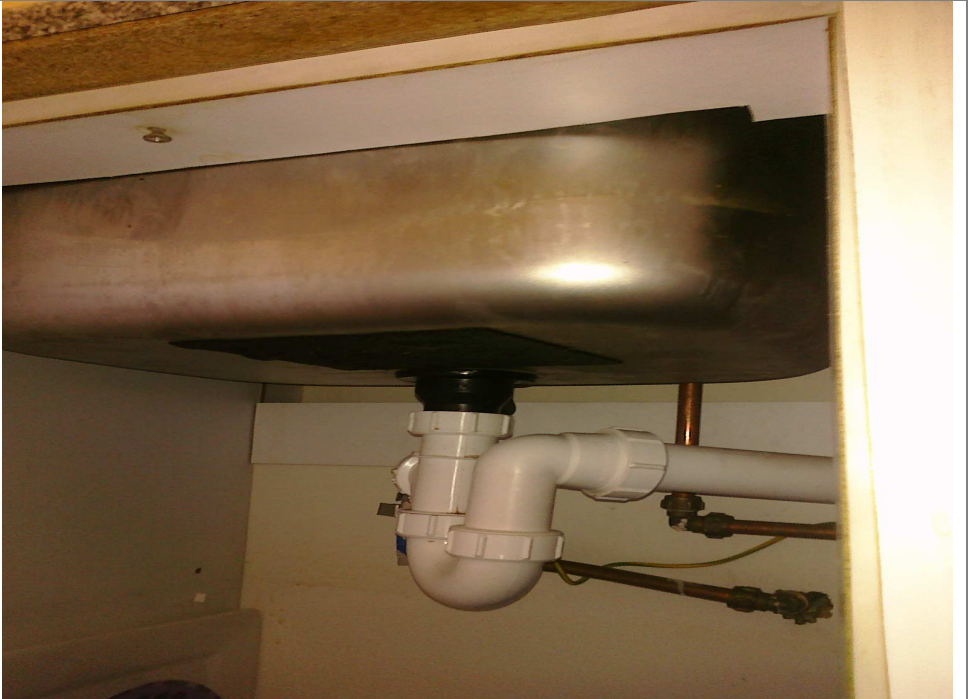
Component:	Thermoplastic	Sample No:	N/A
Sampled By:	C Stephenson	Asbestos:	CHRYSTILE

Condition:	Fair

Friability:	Low		
Surface Treatment:	N/A		
Position:	Internal		
Accessibility:	High		
Exposure:	Maintenance		
Room/Area Size:	N/A		
Approx. Amount of Material at Location:	1 no.		
Photo Number:	020	Action Priority:	N/A

Comments:	Bitumen acoustic sink pad.
Recommendation:	Remove prior to demolition / refurbishment

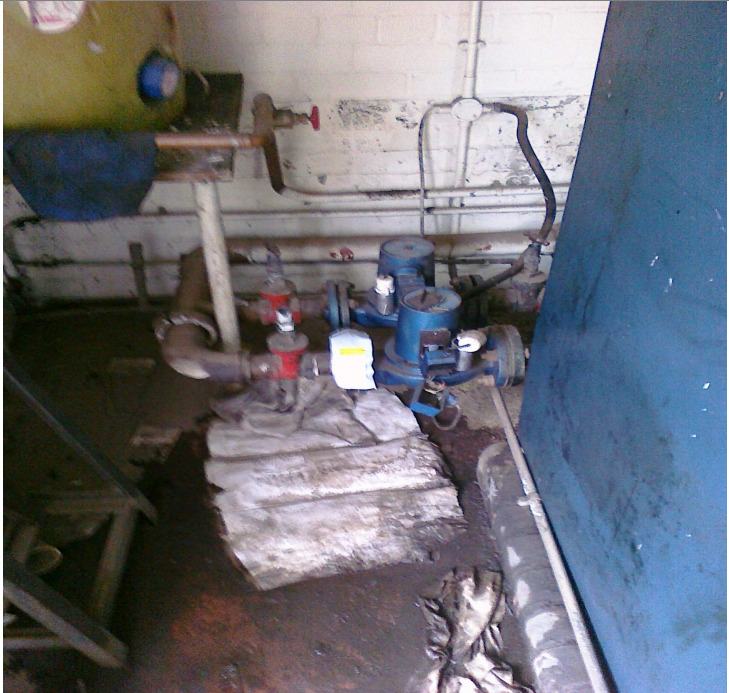
Sample Location: Office Block – Plant Room – Pipework gaskets, Tap Department Storage Area – Loose Gaskets

The sample of the CAF gaskets within the above areas have been found to contain Chrysotile (white asbestos).

Component:	CAF Gasket	Sample No:	OG/32/02
Sampled By:	C Stephenson	Asbestos:	CHRYBOTILE

Condition:	Fair

Friability:	Low		
Surface Treatment:	N/A		
Position:	Internal		
Accessibility:	Low		
Exposure:	Maintenance		
Room/Area Size:	N/A		
Approx. Amount of Material at Location:	10 no.		
Photo Number:	021	Action Priority:	N/A

Comments:	CAF Gaskets to pipework within plant room.
Recommendation:	Remove prior to demolition / refurbishment

The *Control of Asbestos Regulations 2006* does not require the use of a licensed asbestos removal contractor for the removal of asbestos containing woven products. However they do require them to be disposed of as asbestos waste and for the removal to be carried out under controlled conditions, due to the possibility of airborne fibre release.
