**REPORT ON THE TYPE THREE DESTRUCTIVE
SURVEY TO LOCATE AND ASCERTAIN THE NATURE
OF SUSPECTED ASBESTOS BASED MATERIALS**

**CLARKSON OSBORN
100 Penistone Road
Sheffield
S6 3AE**

**Dated: 29th October 2009
REPORT No: ASC/SUR/CS/0096**

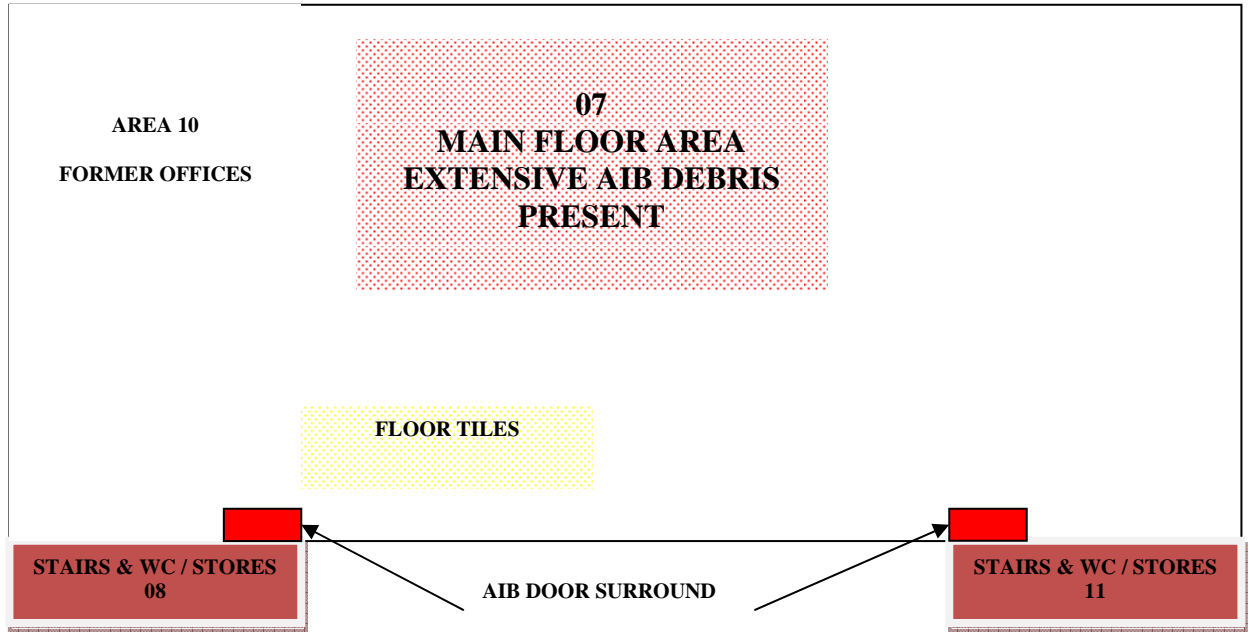
Front Block Third Floor Plan

MB/09/02	Front Block – Third Floor – Ceiling Panels and Extensive Floor Debris ~ 300 sqm	AIB Boarding and Extensive Debris to Floor Areas	Amosite / Chrysotile	N/A
MB/12/02	Roof Area – Tank Room Door Panel ~ 3 sqm (Damaged)	AC Panel to Door Set ~ 3 sqm	Chrysotile	N/A
MB/13/01 & 02	Covered Entrances – Area 13 – Pipework Insulation ~ 30 linn	AI to Service Pipework at High Level	Crocidolite/Amosite/Chrysotile	N/A
N/A	Tap Department – Area 10 – Loose Gasket on Floor	Loose Gasket – Labelled as asbestos	Chrysotile	N/A
TD/11/01 & 02	Tap Department – Area 11 Machine Room – Roof Lining and Wall Panels ~ 400 sqm	Asbestos Coating to the Roof/Wall Lining Panels ~ 5mm in Thickness	Chrysotile	N/A
